Food detection in medieval acoustic vessels: A case study from the early gothic churches in Myšeneč and Kovářov (South Bohemia)

Filip Facincani – Jaroslav Pavelka

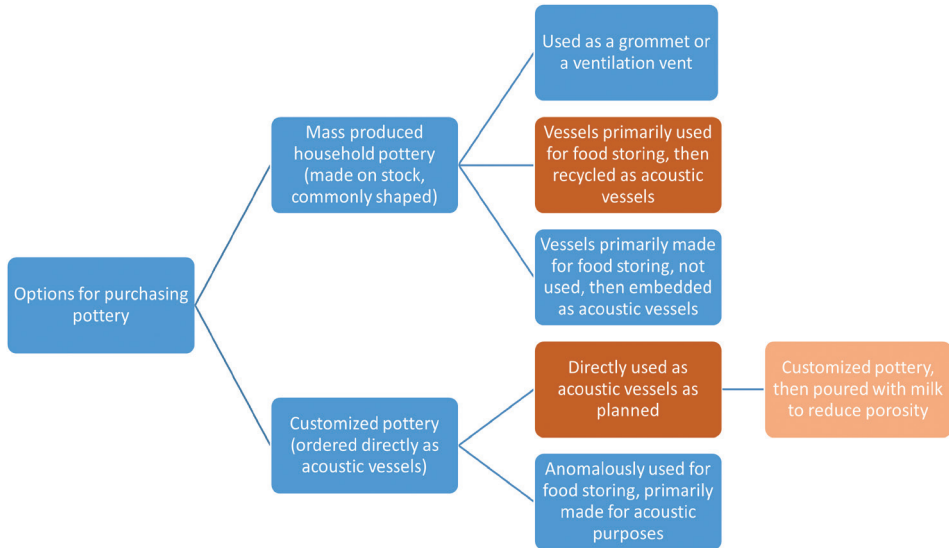
Fig. 1. Diagram indicating the possibilities for how vessels were used. Orange colour indicates the cases record in Myšelec and Kovářov.

However, it should also be noted that the acoustic role of ceramic vessels is just an assumption that cannot be confirmed without reservation for all the examples known so far. In addition, the positive or negative signal of food residues does not preclude the use of the vessels as acoustic ones, but it says a lot about how the chosen technological solution was achieved and the modelling of the building project itself. It is also important to point out that even if the vessels could not improve the acoustics, it does not mean that they were not fitted for that purpose. Even though the role was intended to be acoustic, there are still several possibilities as to what kind of vessel to use for these purposes (*Fig. 1*).

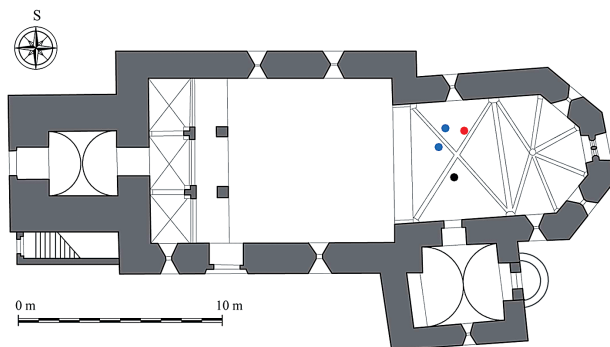
Fig. 2. Church of St. Gall in Myšeneč, ground plan with vessels marked. Black – unsampled vessels; blue – vessels with a negative result; red – vessel positive result (according to *Varhaník – Zavřel 1989*, modified).

of vessels were placed without any recognisable pattern (*Fig. 2*); in Kovářov, the vessels were arranged in a roughly regular way aligned to the longitudinal axis of the presbytery (*Fig. 3*).

From the six tested samples, only two were positive, one for each site (*Tab. 1; Fig. 2 and 3*). In the case of Kovářov, we managed to detect a relatively strong signal for gliadin, which points to the presence of grain in one of the vessels. In Myšenec, casein residues were found again in only one vessel, proving the presence of mammalian milk (we did not attempt to determine the species).

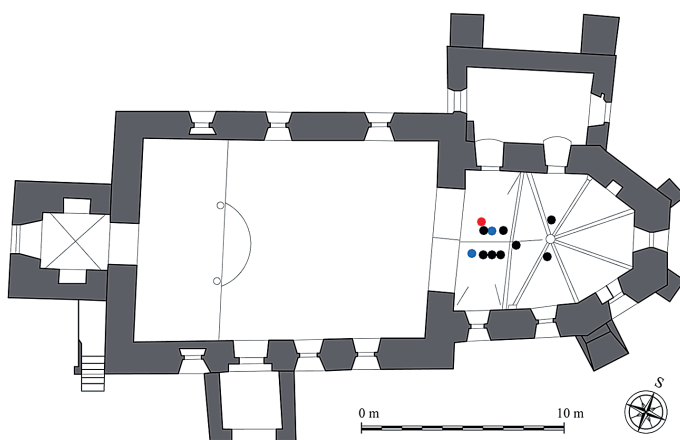
Fig. 3. All Saints Church in Kovářov, ground plan with vessels marked. Black – unsampled vessels; blue – vessels with a negative result; red – vessel positive result (according to *Sommer 1997*, modified).

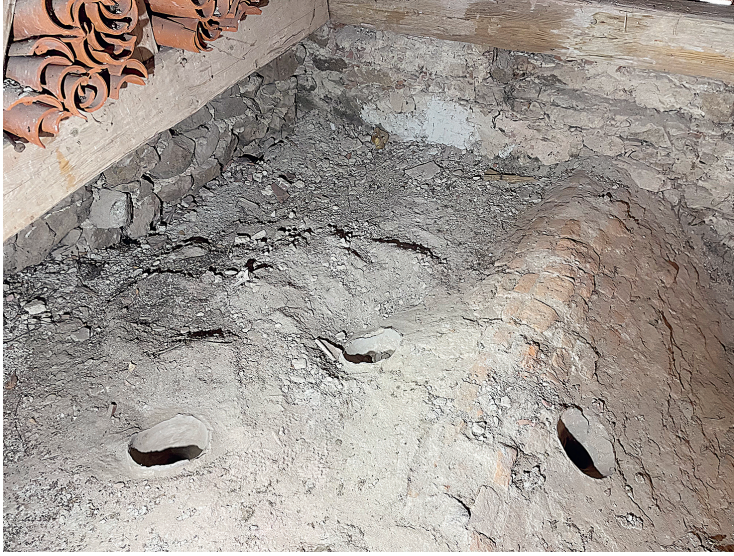
Fig. 4. Church of St. Gall in Myšeneč, attic, brick vault of choir with embedded vessels (photo by F. Facincani).

Four ceramic vessels are preserved in the choir vault of the Church of St. Gall in Myšeneč (*Fig. 4*). Here, the vessels were placed asymmetrically near the top of the vault. They

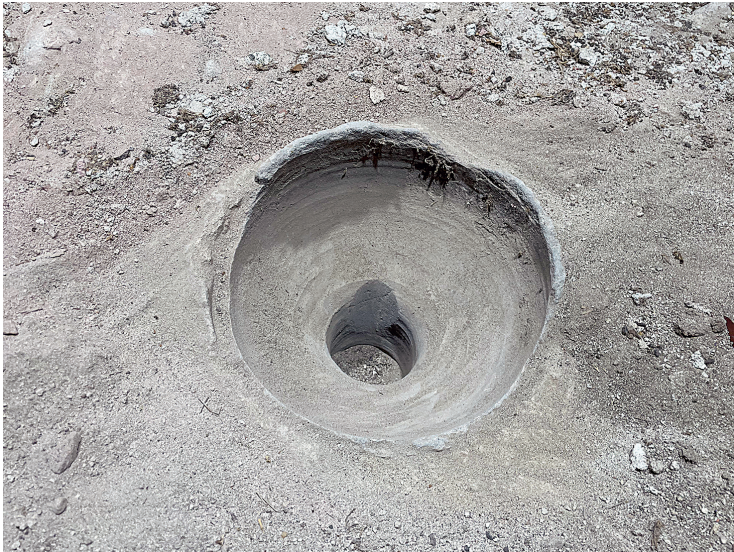
Fig. 5. Church of St. Gall in Myšeneč, vessel no. 1 (photo by F. Facincani).

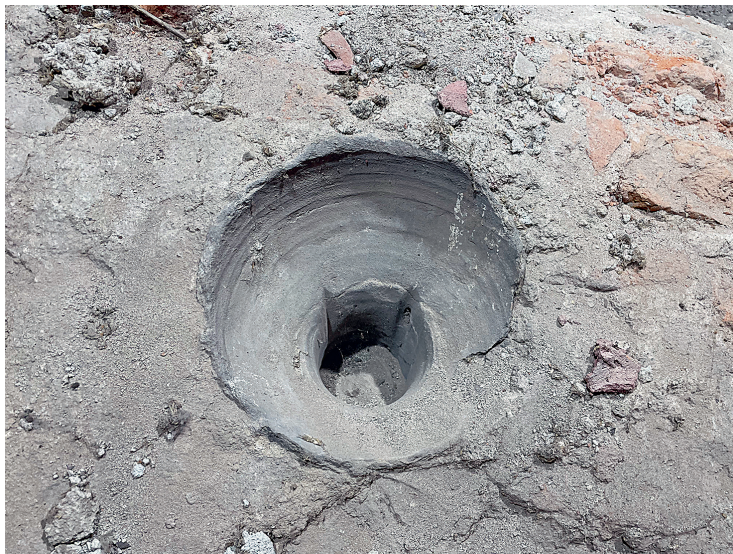
Fig. 6. Church of St. Gall in Myšenec, vessel no. 3 (photo by F. Facincani).

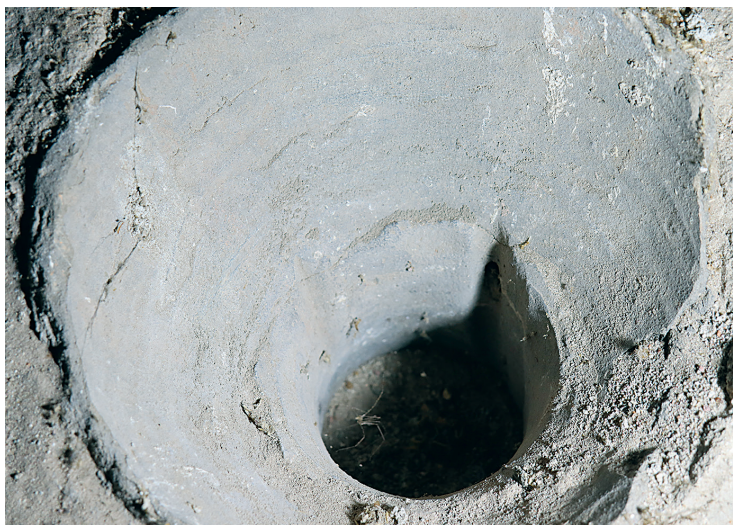
Fig. 7. Church of St. Gall in Myšenec, detail of vessel junction (photo by F. Facincani).

were made of two pieces; the neck as an individual part was pressured into the body, jointed by an unknown rectangular tool. There are even two anomalous joining methods that are visible. Quite deep rectangular traces at the point of the junction of the neck and the body are prevailing (*Fig. 6; Fig. 7*, noticed by *Varhaník – Zavřel 1989*), but in one case the joint is smooth with just one wide curvilinearly-shaped depression (*Fig. 5*). Thus, we can see two different and not common types of junctions caused by the cooperation of two potters or an alternative technological method. Considering that the rectangular joints would have been possibly visible from the outside, their appearance could also signify that the vessels were not ordinary household pots.

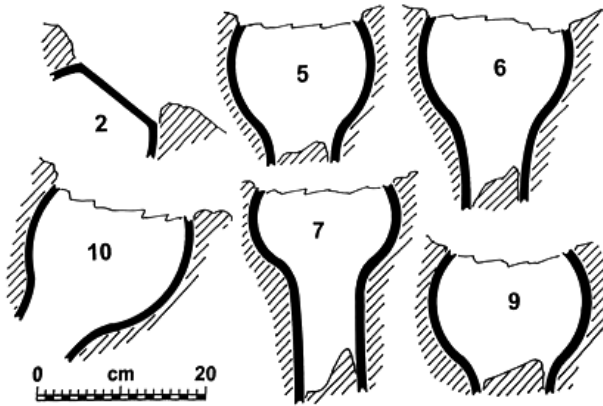
Fig. 8. All Saints Church in Kovářov, cross sections of vessels (according to Sommer 1997).

The ceramic vessels set into the vault of All Saints Church in Kovářov were first published in a short study by Sommer (1997); quite rightly, he labelled them as a *system* of acoustic vessels, alluding to the fundamental difference in their number and arrangement in contrast to Myšelec. Compared to the vessels in Myšelec, the vessels in Kovářov are smaller in size, thin-walled, made of a single piece, and seem to be an example of a much higher quality pottery production than in Myšelec. In the set from Kovářov, vessels are similar in shape but vary in size and proportion (Fig. 8, see Adámek – Sommer 1997, 11).

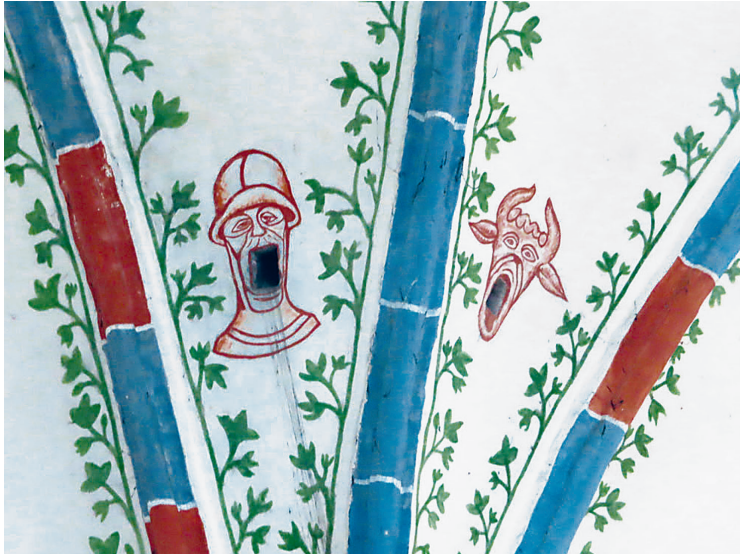
Fig. 9. Church of Saint Mary in Kamień Pomorski, vault (photo by M. Kubínová).

the vault webs of St. Mary's Chapel in St. Nicholas Church in Stockholm (Storkyrkan) is interpreted in the same way. We also know a similar situation from St. Mary's Cathedral in Kamień Pomorski (Fig. 9). Here, rectangular holes set in the same position are emphasised by painted faces with open mouths and a yelling expression. This decoration itself may indicate an awareness of the acoustic role of the holes. However, the setting of the ceramic vessels in this church precludes their rectangular shape.

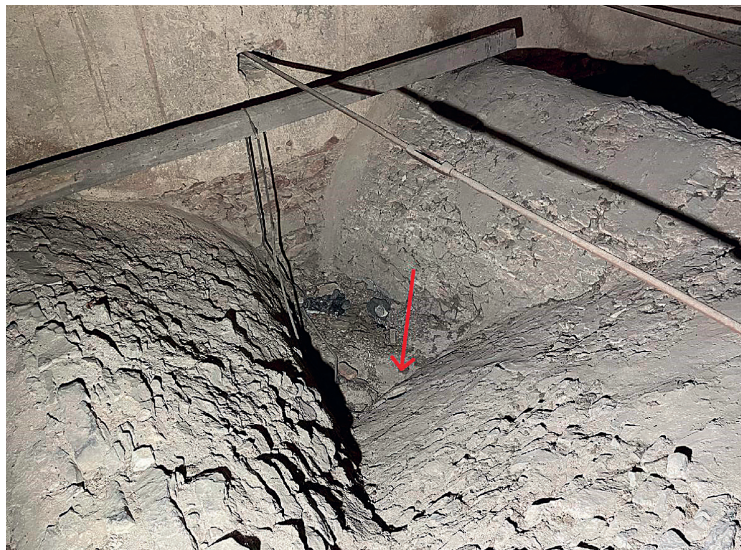
Fig. 10. Church of Saint Adalbert in Jílové u Prahy, vault of choir with a vessel marked by an arrow (photo by F. Facincani).

Three ceramic vessels were found in the choir vault of the Church of St. Adalbert in Jílové u Prahy and published by Vít Jesenský in 1995. As previous research suggested, their bottoms were probably destroyed during some later reconstruction of the roof truss (Jesenský 1995, 52). However, the bottoms of the vessels are broken off quite regularly and their rims are evenly aligned with the surface of the vault. No remains of broken sherds were preserved in the rubble or inside the vessels. This situation raises the question of whether it is really the result of the vessels being accidentally stepped through during the more recent reconstruction. At the same time, the vaults in Jílové are extremely steep (Fig. 10) and it is very difficult to get directly to the vessels, not to mention how difficult it would be to step through such a vessel and how likely it was that they would be destroyed all at once. These indications suggest that the vessels were not broken accidentally, but on purpose and as soon as the mortar set. On the other hand, Vít Jesenský (1995) considers the

secondary breakage to be a misunderstanding of the acoustic role and an attempt to use the newly created openings as ventilation vents. Both options are naturally possible. When we accept the ventilation function, it is also important to record empty vault webs, i.e. missing vessels in an otherwise regular pattern. The course of original service footbridges above the vault and in the attic should be considered. In Jílové u Prahy and in Cheb, the vessels were installed in all vault webs except those over which the service footbridges lead. It is probable that such movement structures were also placed here in the Middle Ages. Omitting the vessel under the footbridge would then have prevented dirt from falling into the interior of the church.
